**Fort
Smith**

Lee Creek Reservoir and Lee Creek

Watershed Management Plan

Prepared for the City of Fort Smith
June 1, 2015

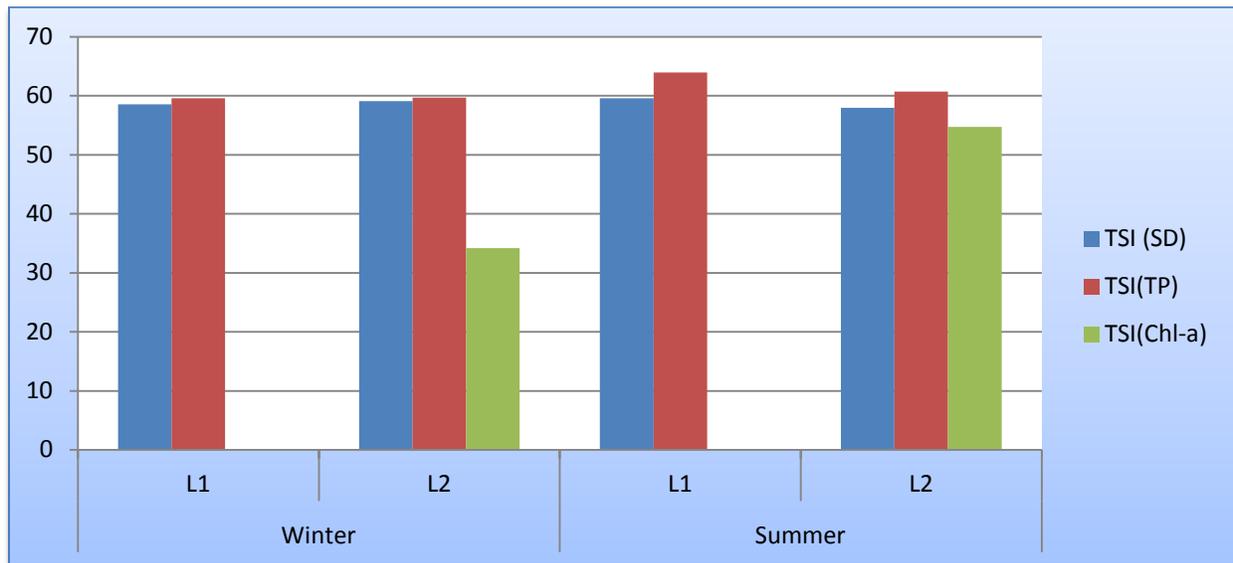
Figure 14. Average Trophic State Index in Lee Creek Reservoir in two Sampling Locations in the Summer (July-August) and Winter (January-February) Months. TSI= Trophic State Index, SD= Secchi Depth, TP= Total Phosphorus, Chl-α= chlorophyll-α.

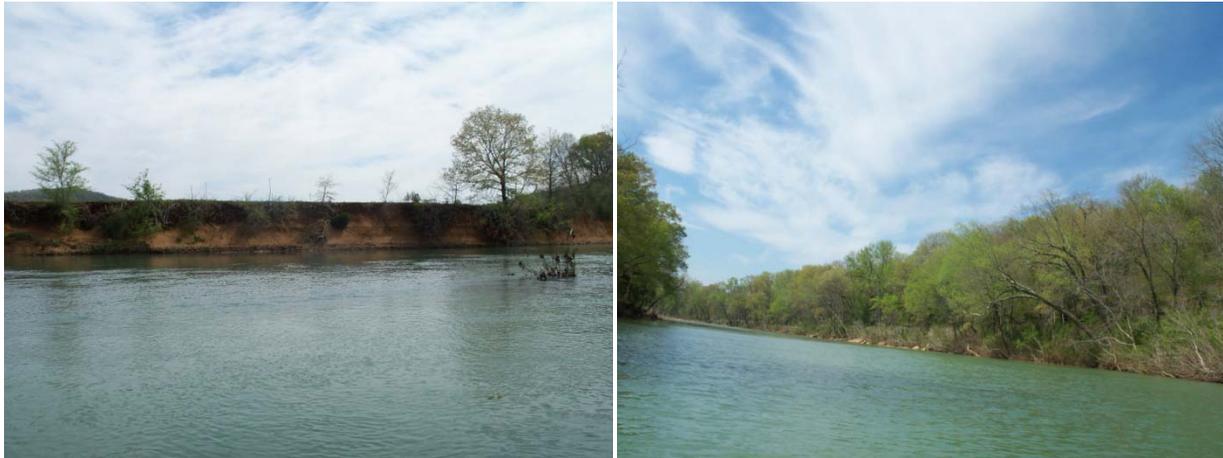
Figure 16. Comparison of an Impacted Riparian Buffer (little to none) to a well developed Riparian Buffer.

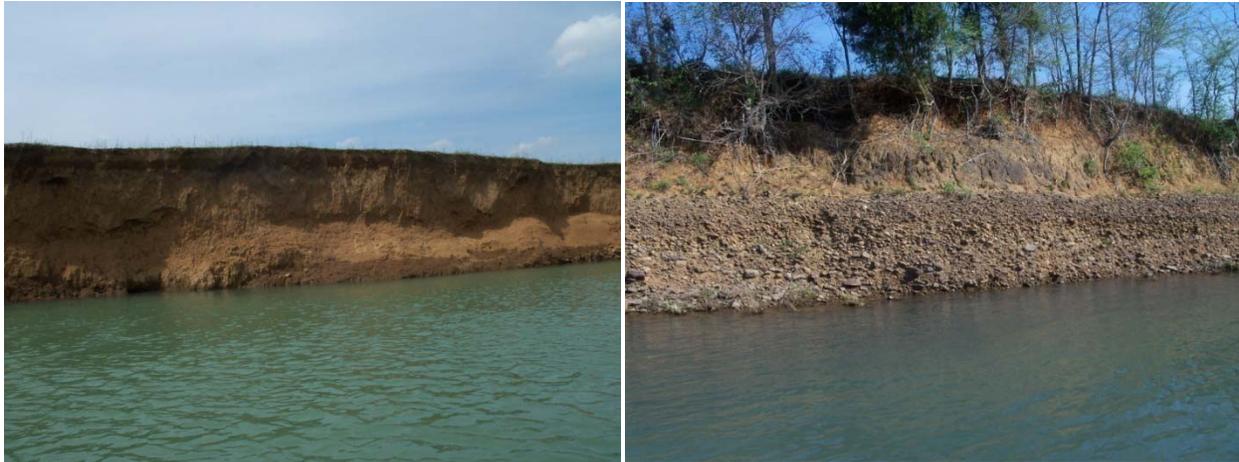
Figure 17. Stream Banks with Very High Bank Erosion Hazard in Lower Lee Creek.

Bank erosion was noted in several areas, particularly in LC-2, LLC-2, JC-1 and MFC-1. Each instance of bank erosion perceived as moderate risk or greater was tagged with a GPS coordinate and the length of the affected bank measured or estimated. The severity of bank erosion was then characterized using a bank erosion hazard index (BEHI) developed by Dave Rosgen (Rosgen, 2006). The BEHI uses several characteristics of the eroded bank (height, vegetated protection, bank angle, soil composition, etc) to calculate an overall score that relates to level of erosion hazard. The possible levels are low, moderate, high, very high, and extremely high. Bank erosion observed in the Lee Creek watershed ranged from moderate active erosion and erosion hazard to extremely high (excessive) active erosion and erosion hazard. Some of the high to extremely high erosion hazard (Figure 17) was in areas where the riparian buffers had been removed and the banks were greater than seven feet high. Moderate to high stream slopes, and the gravel/cobble content of the bank soils in the Lee Creek watershed make the banks susceptible to erosion when not protected by good riparian areas. Stream bank erosion can add hundreds of tons of sediment (and nutrients) to a stream system annually. Five of the eight sub-watersheds in Lee Creek had greater than 20% of their major stream length experiencing active erosion at a moderate level or greater.

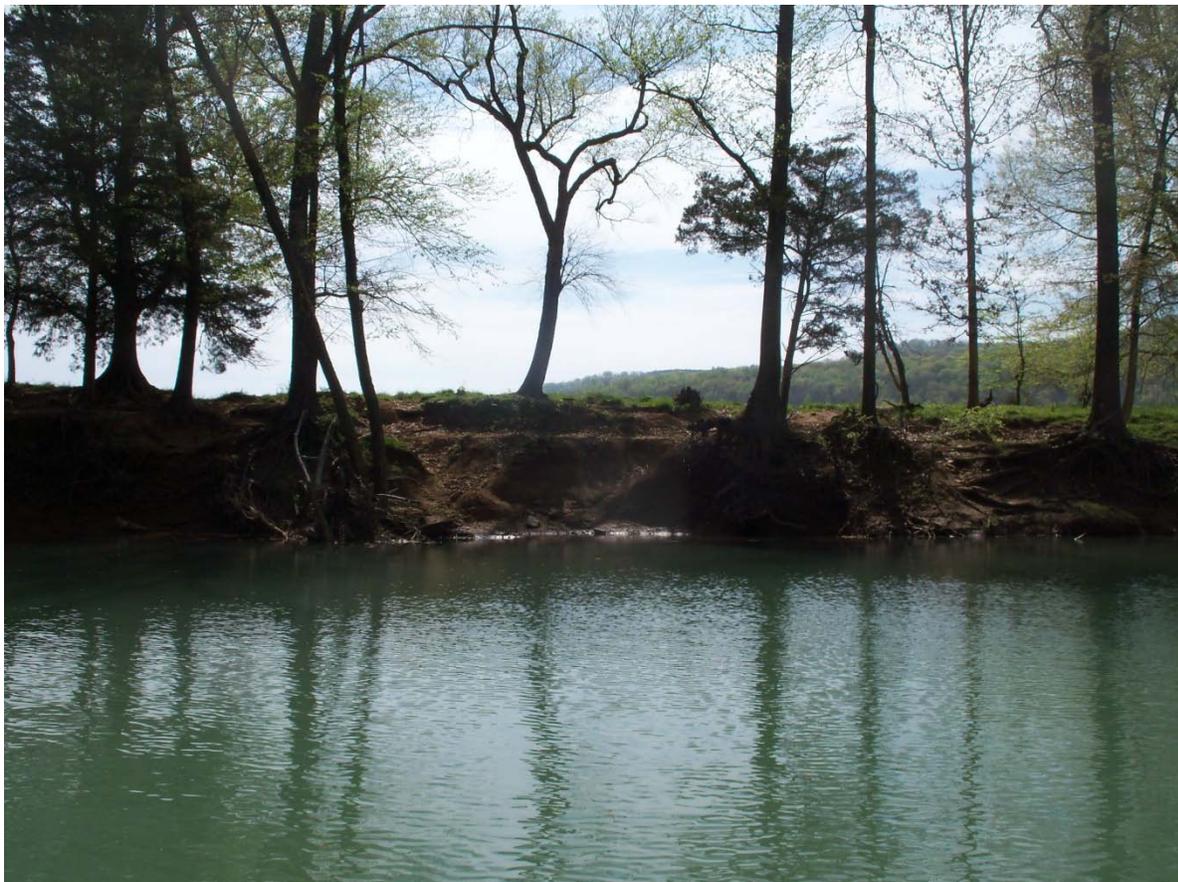
Figure 18. Typical Storm Water Outfall from Pasture in Lee Creek.

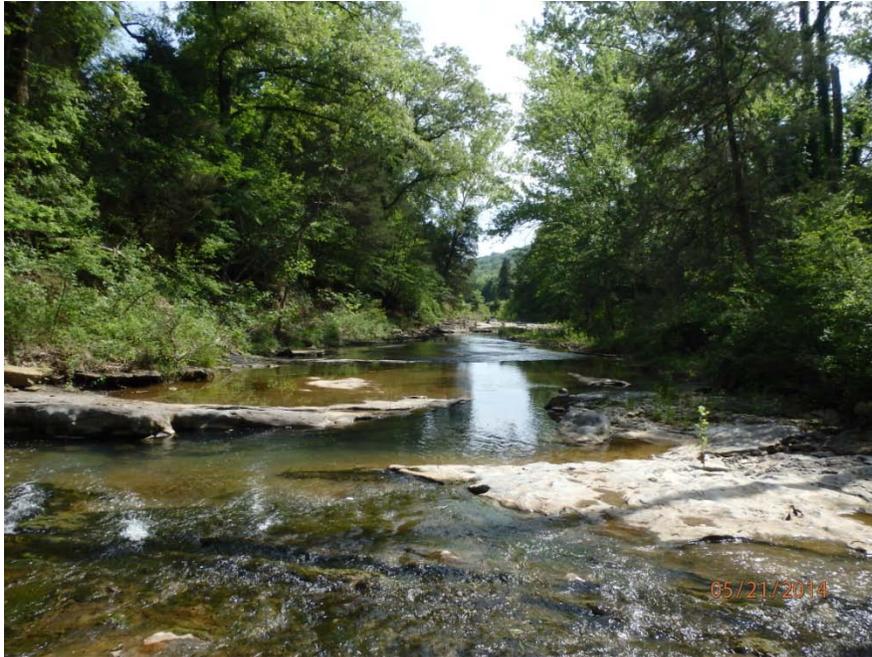
Figure 19. MFC Bedrock Stream Bottom Promotes Algal Growth.

abundant. MFC has a large amount of bedrock substrate and more open areas for sunlight penetration resulting in ideal conditions for periphyton growth (Figure 19.)

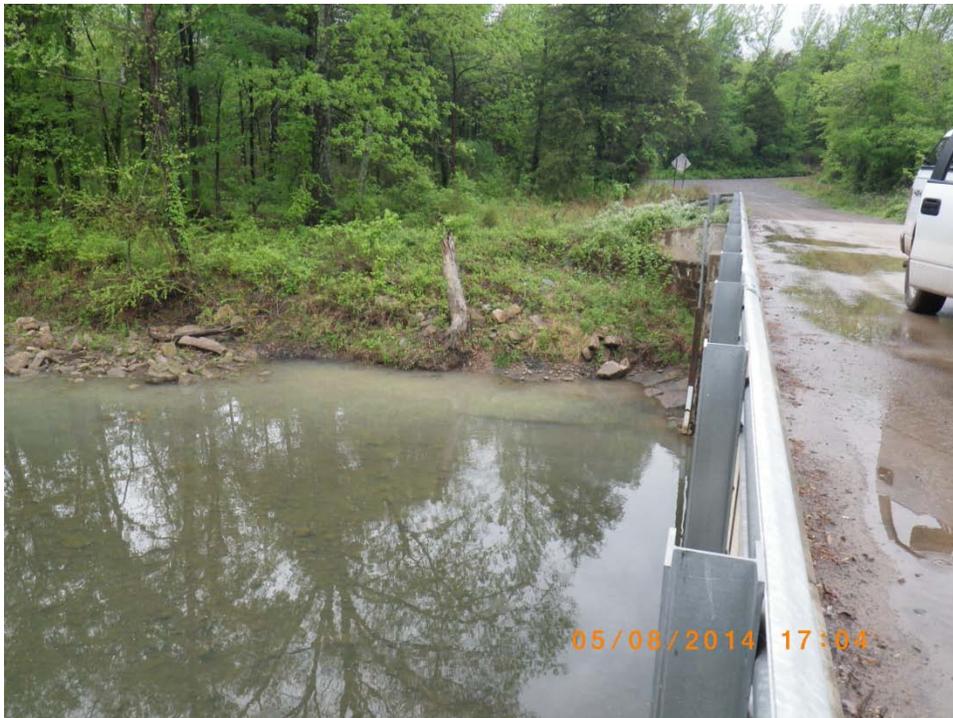
Figure 24. Sediment Plume entering Cove Creek from Unpaved Road Runoff.

Unpaved roads (gravel forest roads and OHV trails) are common in the Lee Creek Watershed. There are over 300 miles of unpaved roads in the watershed. During storm events these roads can transport significant loads of sediment into adjacent streams (Figure 24). The magnitude of the sediment load varies dependent on many factors including; proximity to streams, condition of the road, slope and the design of the road. Forest roads can be designed to include BMPs that reduce erosion and transport of sediment.
