# Poteau River HUC-8 Watershed Management Plan

## Poteau River Watershed Management Plan

319 Project Number: 20-1100

GBMc & Associates Now Alliance Technical Group 219 Brown Lane Bryant, AR 72022

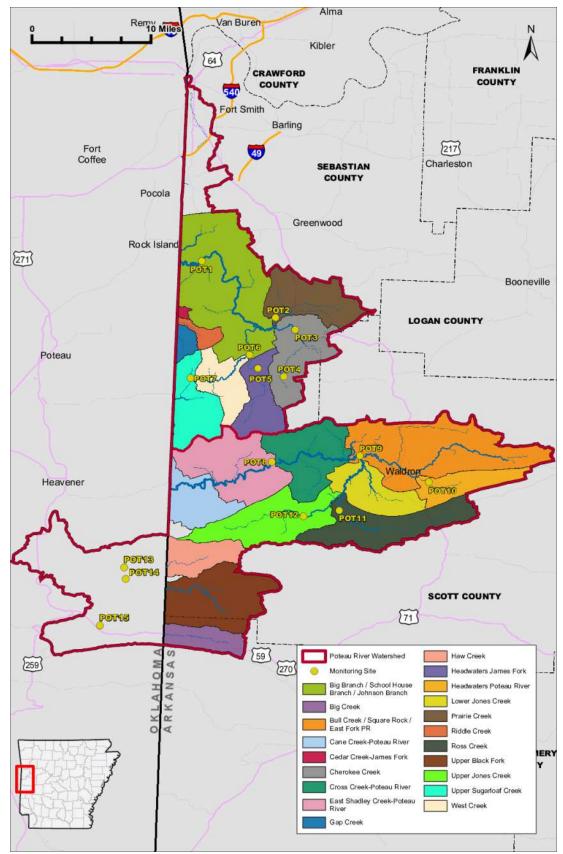
Figure 2.1. General overview of PRW showing subwatersheds and the University of Arkansas monitoring locations.

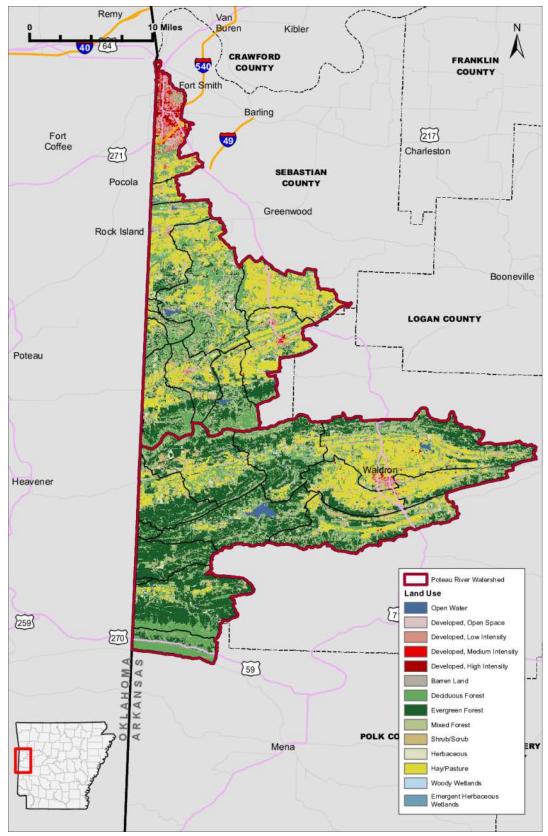
Figure 2.2. Poteau River Watershed land uses (NLCD 2019) with the middle red line dividing the James Fork and Poteau River portions.

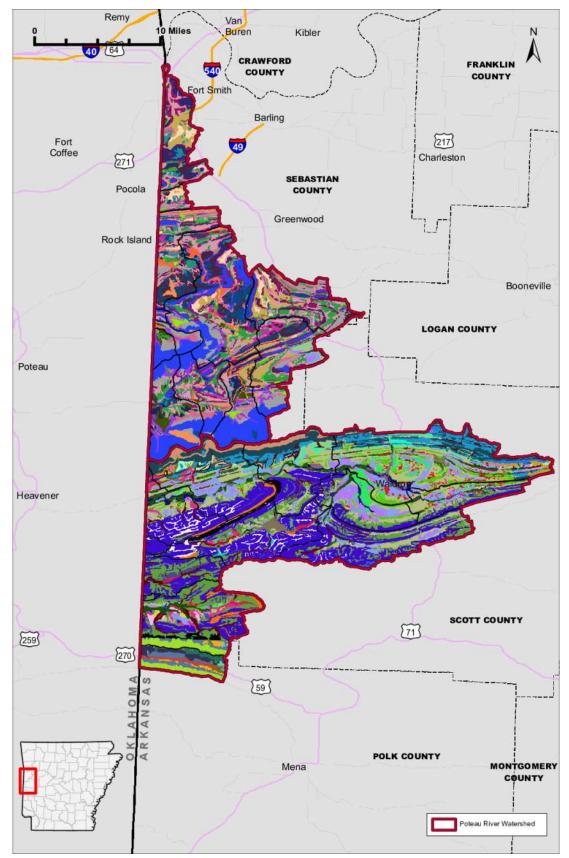
Figure 2.3. Map of soils in the PRW with the middle red line dividing the James Fork and Poteau River portions.

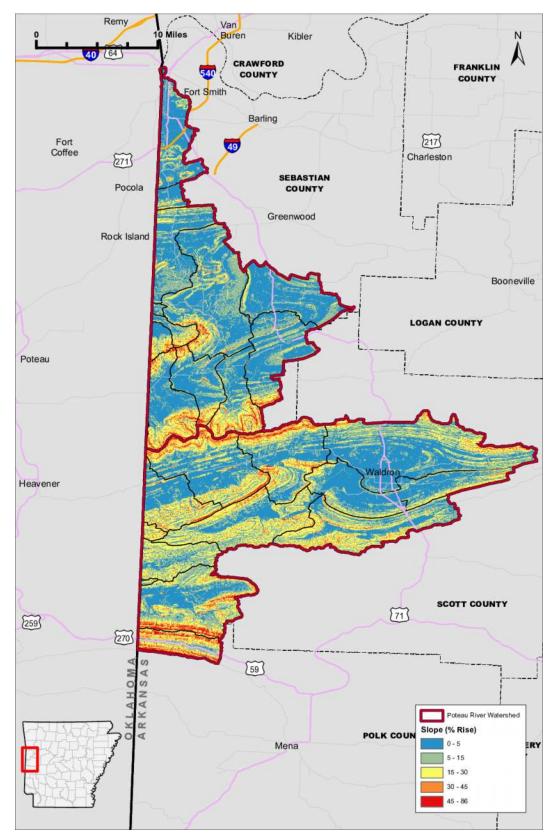
Figure 2.4. Land surface slope in the PRW with the middle red line dividing the James Fork and Poteau River portions.

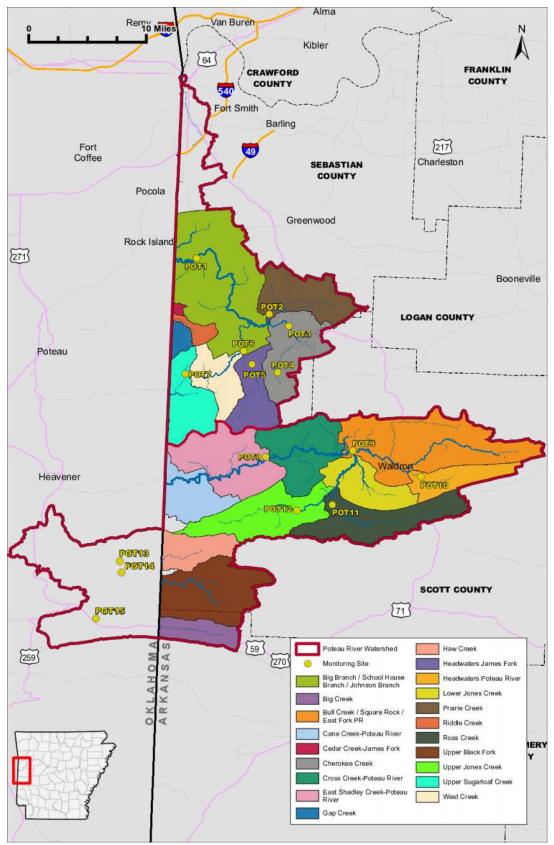
Figure 3.1. University of Arkansas sampling locations within respective subwatersheds assessed.

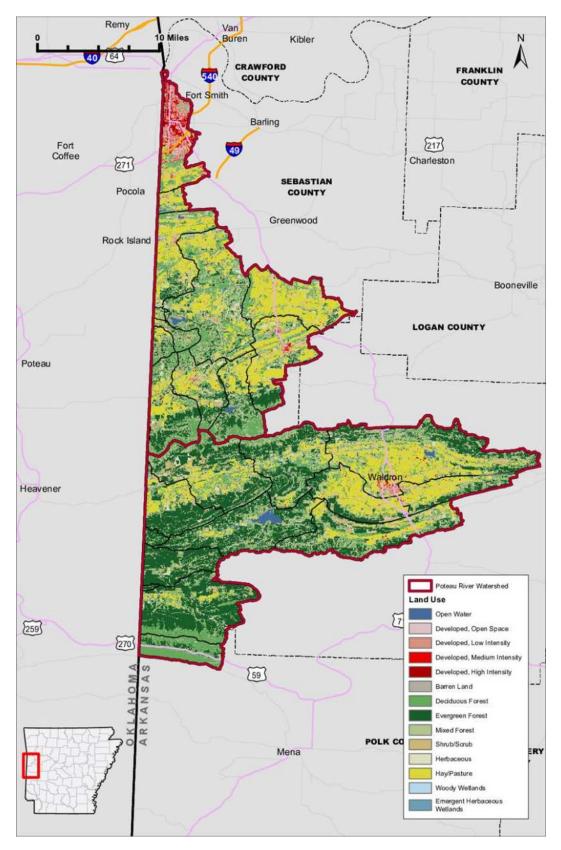
Figure 3.1.1.1. PRW land use land cover by subwatershed in 2019.

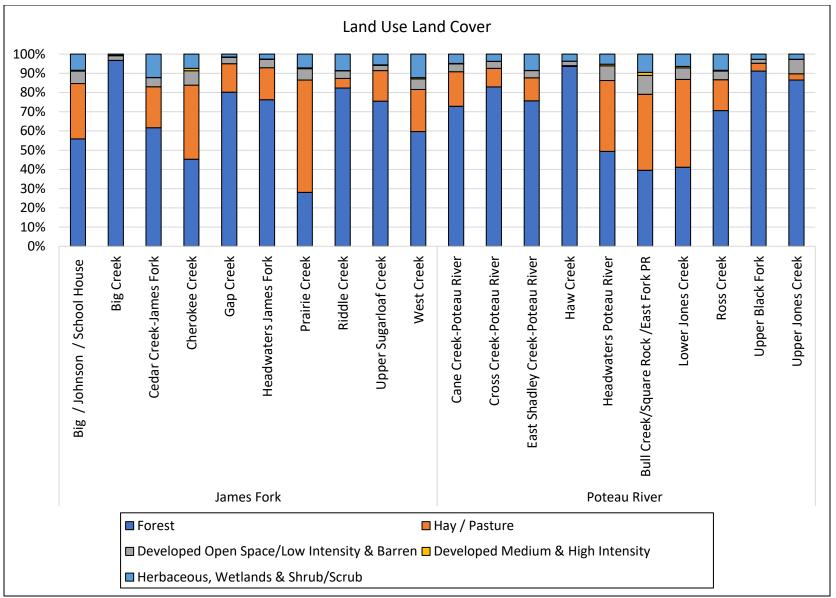
Figure 3.1.1.2 Land use land cover for the Poteau River by subwatershed in 2019.

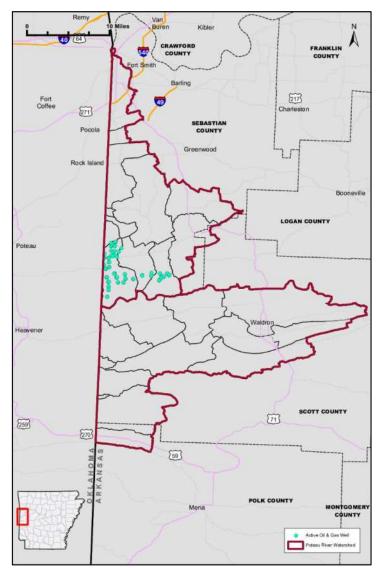
Figure 3.1.2.1. Oil and gas well density in the PRW (Arkansas Oil and Gas commission, 2014).

The Lower Hartshorne Coal Seam is in west Arkansas and has yielded 10 billion cubic feet of natural gas. The western part of the PRW contains the majority of the 395 gas wells (Figure 3.1.2.1) in the watershed. The drilling of natural gas wells and the creation of pipelines to transport and store the gas and access roads to the sites changes the dominant land use in these areas and typically creates additional areas for storm water runoff. These changes could cause an increase in runoff volume and amount of sediment transport originating from the gravel used to build the pads and roads. Therefore, the number of active gas wells was used in the ranking matrix as another potential source for non-point source pollution.

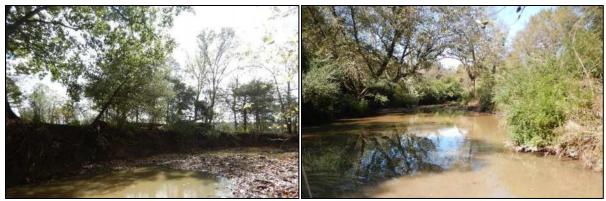
Figure 3.2.1. Comparison of an impacted riparian buffer (Lower James Fork) to a well-developed riparian buffer (Cherokee Creek).

Bank erosion was noted in several areas, particularly in West Creek and Prairie Creek in the James Fork portion of the watershed and BC/SR/EFPR. Each instance of bank erosion was tagged with a GPS coordinate and the length of the affected bank measured or estimated. The severity of bank erosion was then characterized using a bank erosion hazard index (BEHI) developed by Dave Rosgen (Rosgen, 2006). The BEHI uses several characteristics of the eroded bank (height, vegetated protection, bank angle, soil composition, etc) to calculate an overall score that relates to level of erosion hazard. The possible erosion levels are low, moderate, high, very high, and extremely high. Bank erosion observed in the PRW watershed ranged from low active erosion to very high active erosion. Some of the high erosion hazard (Figure 3.2.2) was in areas where the riparian buffers had been removed and the banks were greater than four feet high. Gravel and silt/clay were the dominant stream substrates of these subwatersheds. Gravel is fairly susceptible to erosion; however, silt/clay substrate is the least susceptible to erosion. The soils in the overall PRW are mostly composed of gravelly fine sandy loam, fine sandy loan, and silt loam with a moderate potential for erosion. However, with the amount of pasture land use in the subwatersheds, some banks have eroded more by not being protected by good riparian area.

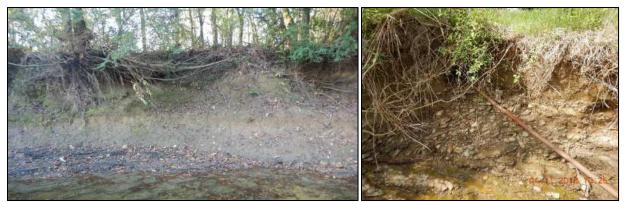
Figure 3.2.2. Streambanks with high bank erosion hazard (left, Prairie Creek; City Main Tributary, Bull Creek).

Stream bank erosion, impacted riparian buffers, and cattle runoff were the major impacts that were observed while completing the USAs. The two streams with the highest stream bank erosion were in the Big Branch / Johnson / School House and Prairie Creek subwatersheds (Figure 3.2.2). Streambank erosion (Ib/year) is a key attribute used in the ranking matrix.

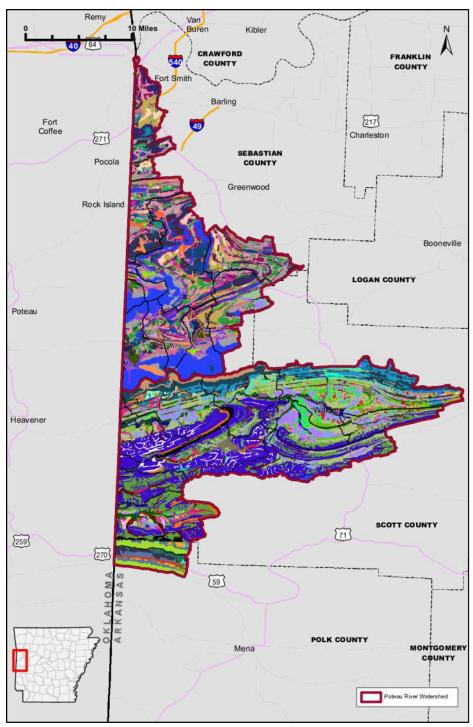
Figure 3.3.4.1 Map of soils in the PRW.

Soils on the land surface in the overall PRW are mostly composed of gravelly fine sandy loam, fine sandy loan, and silt loam with a moderate potential for erosion.

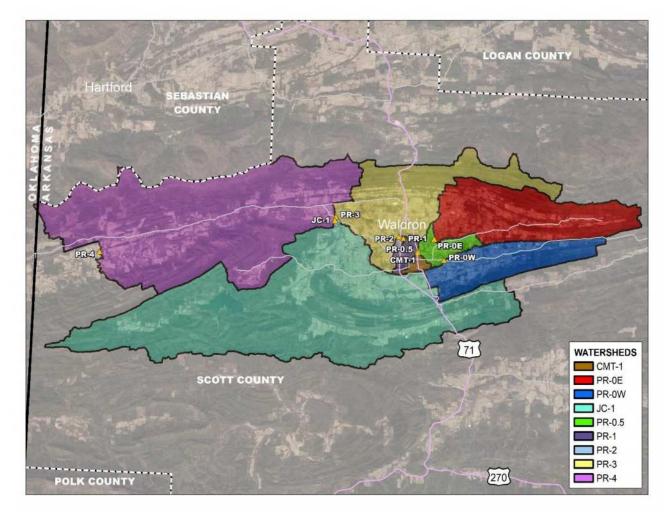
Figure 3.4.1. General overview of the GBMc & Associates Poteau River Watershed Sampling Points and the Subwatersheds Represented by the Sampling. (Grant #17-300).

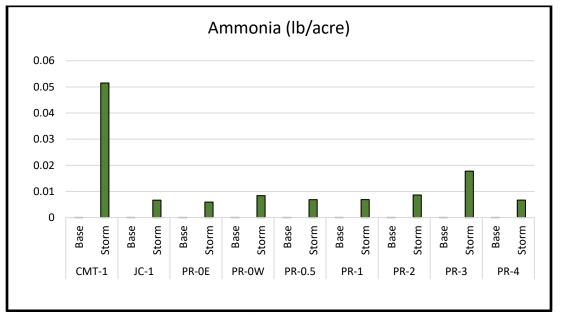
Figure 3.4.1.1. Average ammonia results (lb/acre) from each sampling site during baseflow and storm flow events collected by GBMc and Associates in January 2017-May 2018.

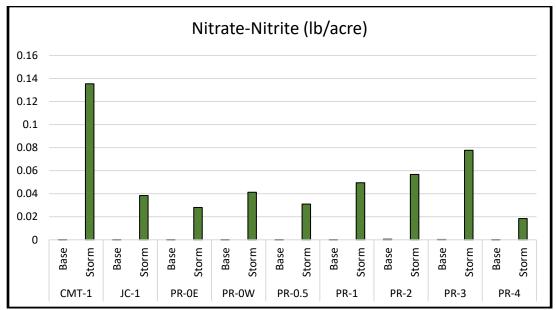
Figure 3.4.1.2. Average nitrate-nitrite results (lb/acre) from each sampling site during baseflow and storm flow events collected by GBMc and Associates in January 2017-May 2018.

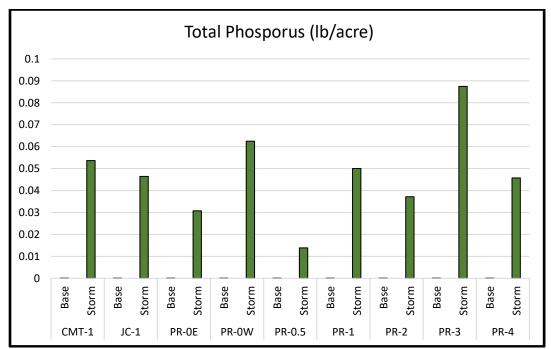
Figure 3.4.1.3. Average total phosphorus results (lb/acre) from each sampling site during baseflow and storm flow events collected by GBMc and Associates in January 2017-May 2018.

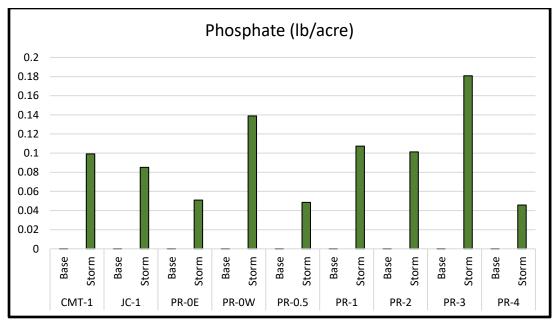
Figure 3.4.1.4. Average phosphate results (lb/acre) from each sampling site during baseflow and storm flow events collected by GBMc and Associates in January 2017-May 2018.

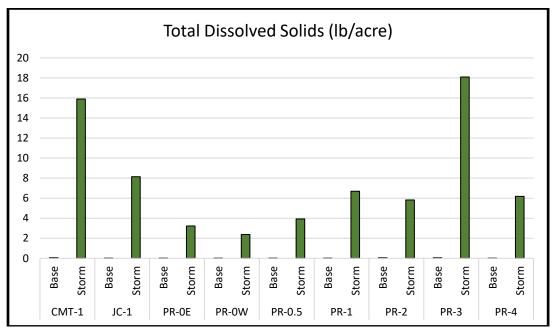
Figure 3.4.1.5. Average total dissolved solids results (lb/acre) from each sampling site during baseflow and storm flow events collected by GBMc and Associates in January 2017-May 2018.

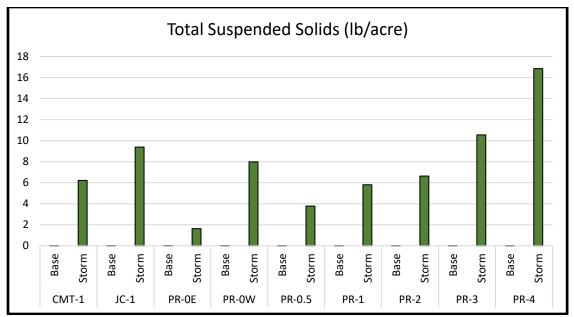
Figure 3.4.1.6. Average total suspended solids results (lb/acre) from each sampling site during baseflow and storm flow events collected by GBMc and Associates in January 2017-May 2018.

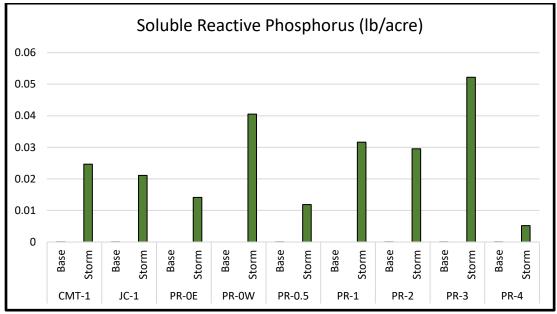
Figure 3.4.1.7. Average soluble reactive phosphorus results (lb/acre) from each sampling site during baseflow and storm flow events collected by GBMc and Associates in January 2017-May 2018.

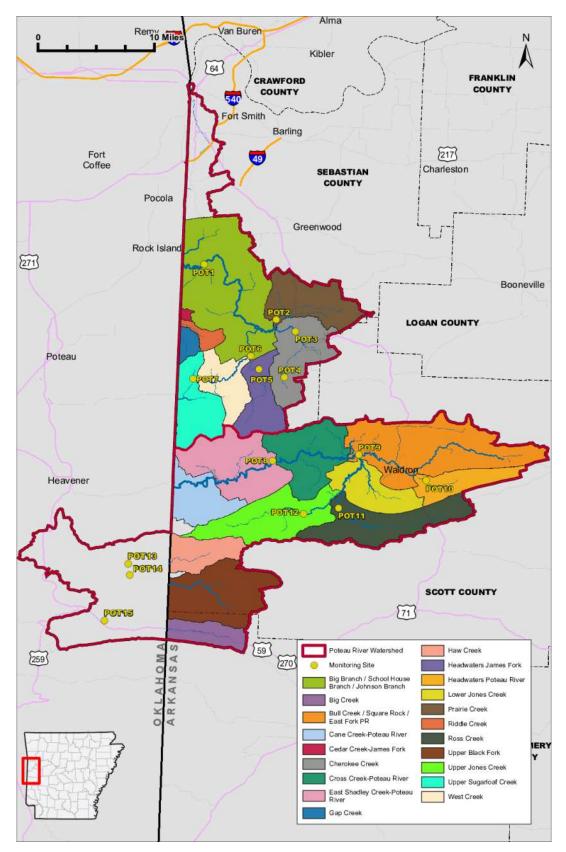
Figure 3.4.2.1. University of Arkansas sample stations in each subwatershed utilized during this study.

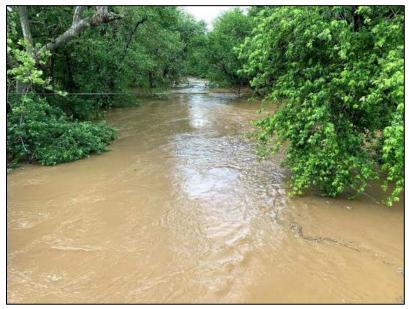
Figure 3.4.2.2. Samples were collected during storm flow conditions throughout the study.

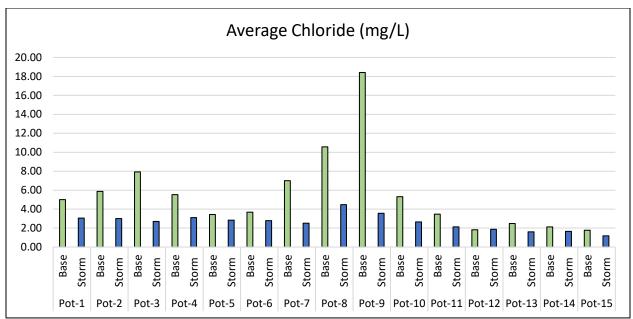
Figure 3.4.2.3. Average chloride base and storm flow concentrations from each subwatershed.

Water quality during storm flow conditions is summarized in Table 3.4.2.2. Storm events were sampled with the goal of each sample being collected prior to the peak instream flow (Figure 3.4.2.2). The concentration of some pollutants increased as flow increased, while other pollutants decreased or remained stable. Most notably TSS (Figure 3.4.2.8) on average increased at least an order of magnitude (on average) during storm flow events. TSS levels were highest at 191.7 mg/L, at Big Branch / Johnson / School House (Pot-1). Other constituents depended upon the watershed as to whether the stormflow concentration was higher than baseflow (Figures 3.4.2.3-3.4.2.8).

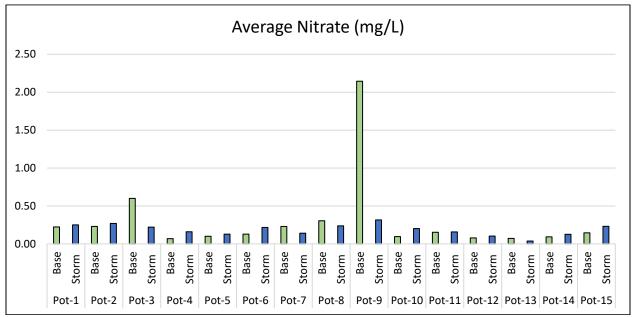
Figure 3.4.2.4. Average nitrate base and storm flow concentrations from each subwatershed.

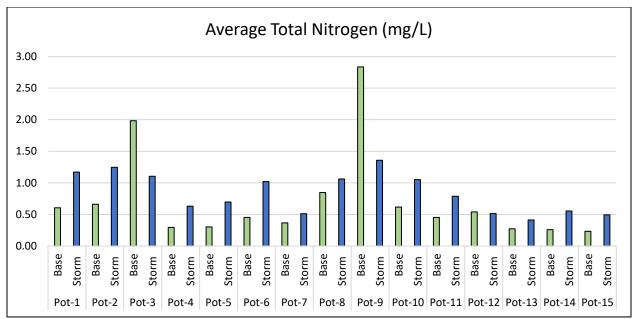
Figure 3.4.2.5. Average total nitrogen base and storm flow concentrations from each subwatershed.

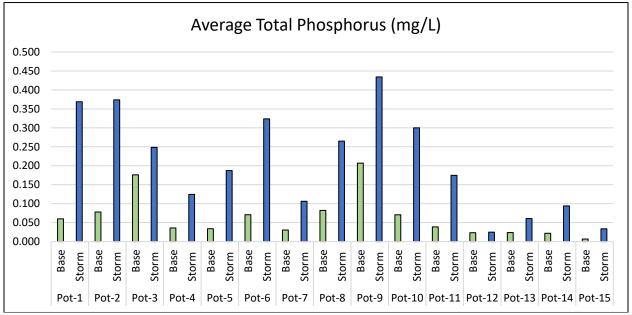
Figure 3.4.2.6. Average total phosphorus base and storm flow concentrations from each subwatershed.

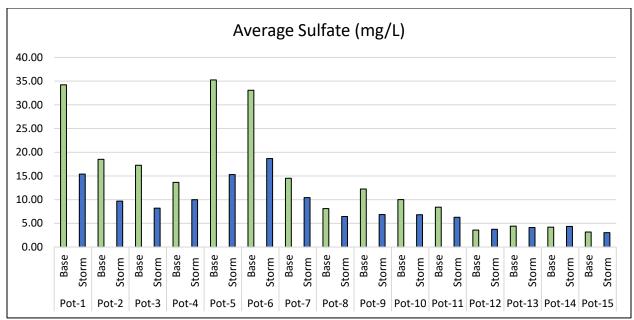
Figure 3.4.2.7. Average sulfate for base and storm flow concentrations from each subwatershed.

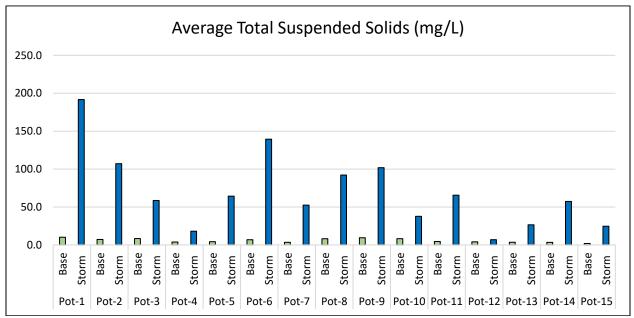
Figure 3.4.2.8. Average TSS base and storm flow concentrations from each subwatershed.

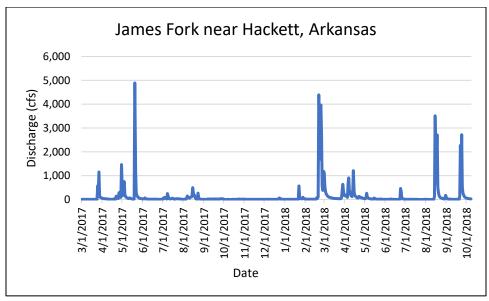
Figure 3.5.1. The USGS discharge data from the James Fork near Hackett, AR (Pot-1).

There were four watersheds that did not have continuous flow data collected, Pot-2, Pot-3, Pot-7, and Pot-13. In these cases, a surrogate site was used to calculate a flow on a per mi<sup>2</sup> basis. Sampling dates mostly matched dates water quality was collected. Once the flow/mi<sup>2</sup> was calculated, the missing watershed's area was multiplied by the flow/mi<sup>2</sup> for loading to be calculated.

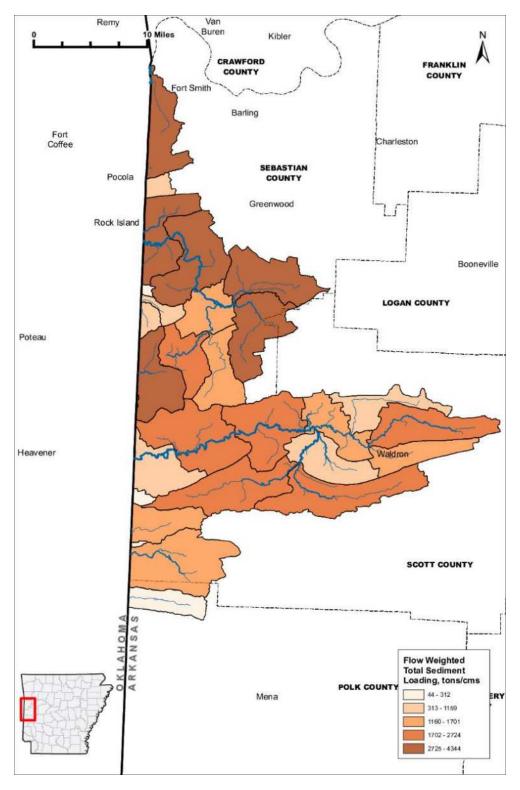
Figure 3.6.1. Priority subwatersheds within the Poteau River Watershed based on flow-weighted loads of sediments.

The highest priority subwatersheds (i.e., 81-100 percentiles) based on sediment loads were Big Branch-James Fork, Cedar Creek-Poteau River, Cherokee Creek, Johnson Branch-James Fork, Prairie Creek, and Upper Sugarloaf Creek (Figure 3.6.1). These six subwatersheds make up about 28% of the PRW but contributed 43% of the sediment loads. The highest priority subwatersheds based on total phosphorus flow-weighted concentrations were Big Branch-James Fork, Cedar Creek-Poteau River, Cherokee Creek, East Fork Poteau River, Lower Jones Creek, and Prairie Creek (Figure 3.6.2). These six subwatersheds make up about 27% of the PRW but contributed 50% of the total phosphorus loads. Finally, the highest priority subwatersheds based on total nitrogen flow-weighted concentrations were Big Branch-James Fork, Cedar Creek-Poteau River, Johnson Branch-James Fork, Lower Jones Creek, Prairie Creek, and Ross Creek (Figure 3.6.3). These six subwatersheds make up about 57% of the PRW but contributed 50% of the total phosphorus loads.

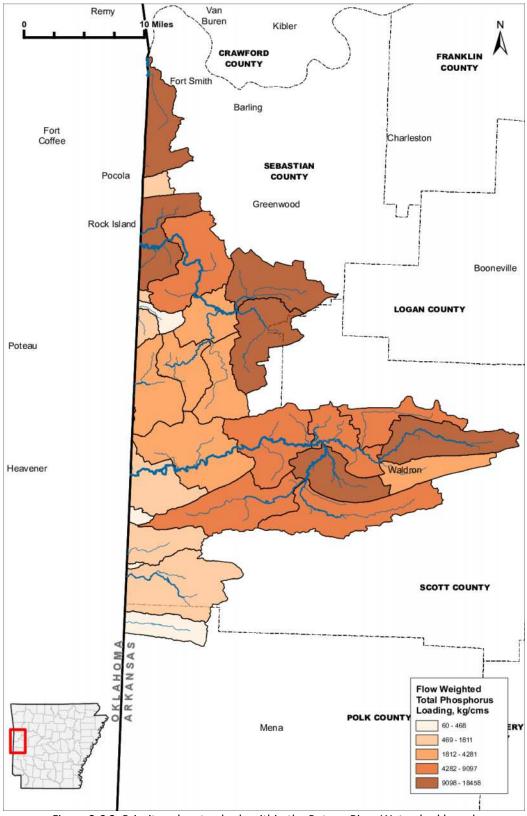
Figure 3.6.2. Priority subwatersheds within the Poteau River Watershed based on flow-weighted loads of total phosphorus.

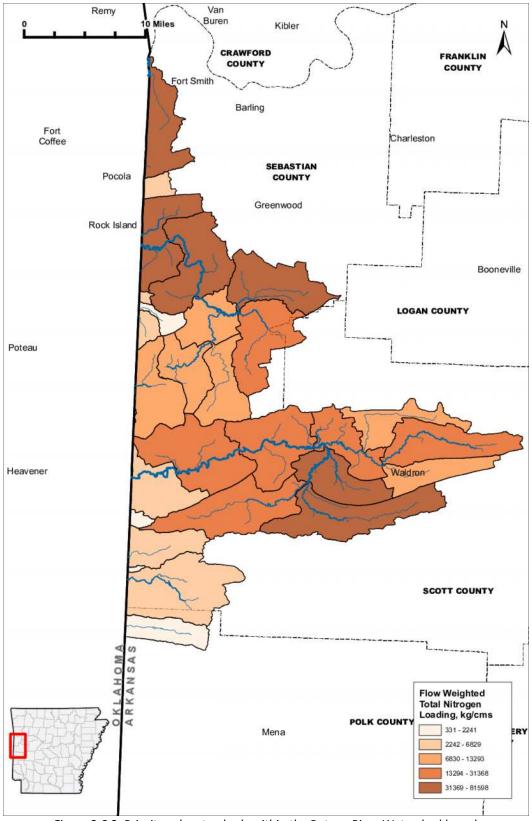
Figure 3.6.3. Priority subwatersheds within the Poteau River Watershed based on flow-weighted loads of total nitrogen.

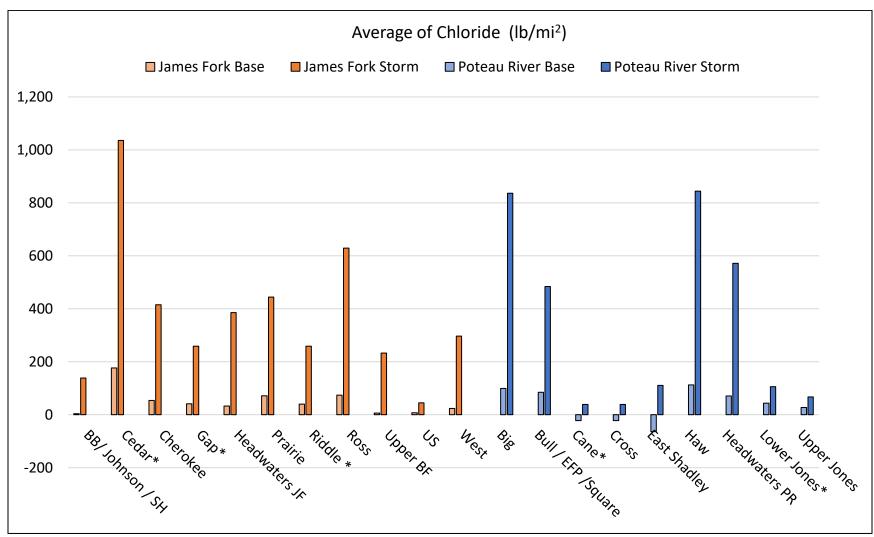
Figure 4.1.1. Base and storm flow average loads of chloride (lb/mi<sup>2</sup>)

Figures 4.1.4-4.1.7 depict the portion of pollutant loading attributed to each subwatershed for average chloride, total nitrogen, total phosphorus and TSS base and storm flow loads. Big Creek (Pot-15), Headwaters James Fork (Pot-5), Ross Creek (Pot-11) and West Creek (Pot-6) were identified with the highest loading of TSS and will receive higher priority for management. Load reductions will be accomplished accordingly for these key subwatersheds as well as other subwatersheds according to the plan outlined in Sections 5 and 6. TSS and nutrient loading in subwatersheds was used in the ranking matrix.

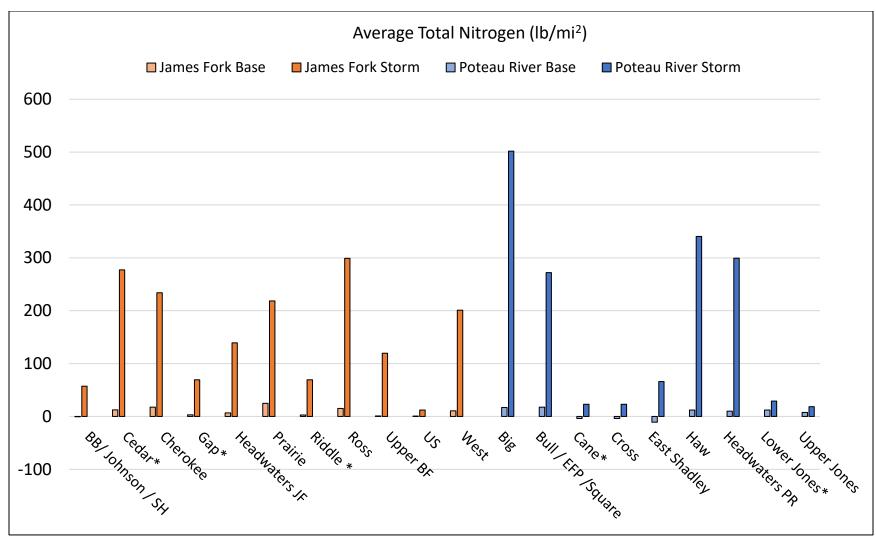
Figure 4.1.2. Base and storm flow average loads of total nitrogen (lb/mi<sup>2</sup>).

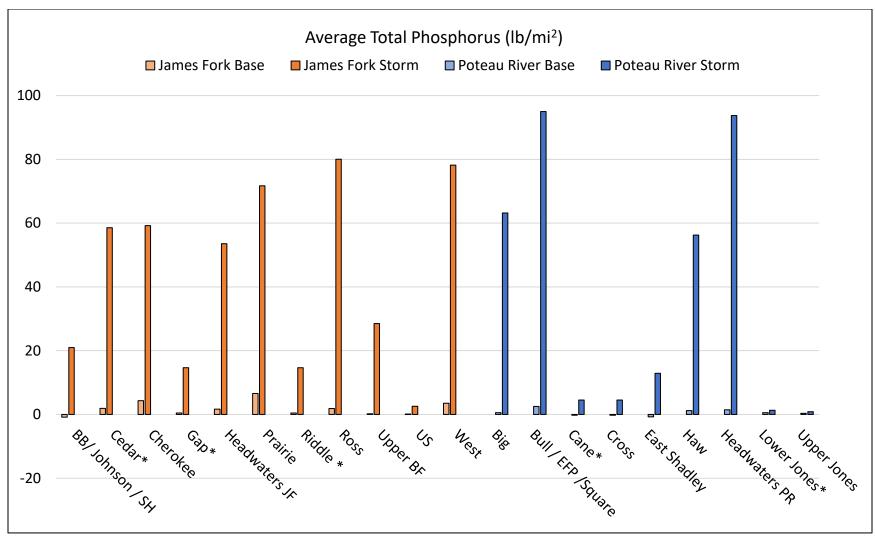
Figure 4.1.3. Base and storm flow average loads of total phosphorus (lb/mi<sup>2</sup>).

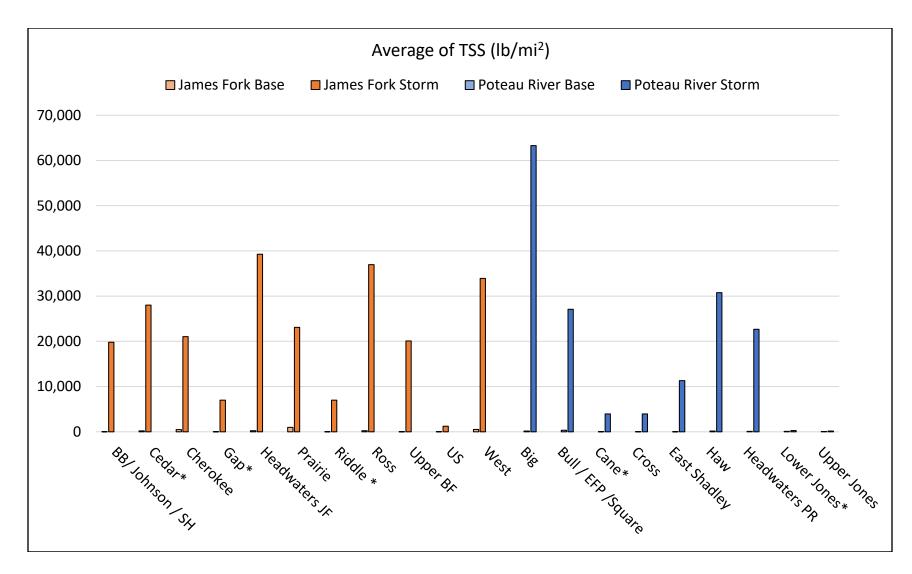
Figure 4.1.4. Base and storm flow average loads of total suspended solids (lb/mi<sup>2</sup>).

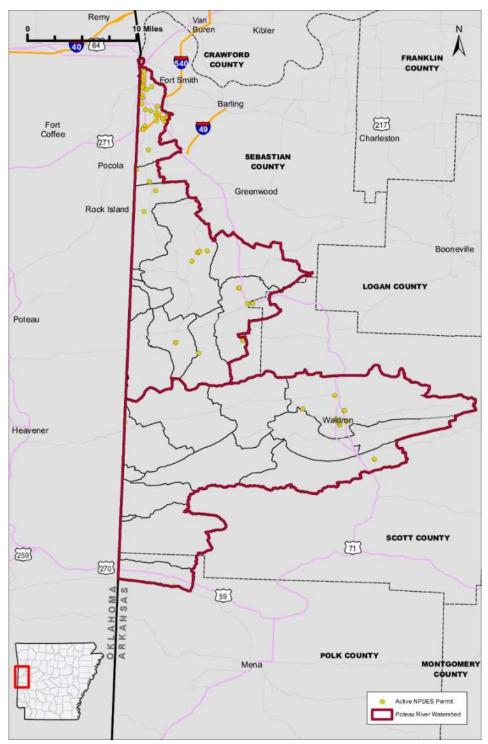
Figure 5.1.1. Active NPDES permits in the PRW.

The city of Huntington has a design flow of 0.11 MGD and the outfall is captured by monitoring location Pot-2 in the Prairie Creek subwatershed. Effluent limits for each of these entities are presented in Table 5.1.1. It should be noted that the Tyson Poultry discharge (phosphorus limit 1.5 mg/L) and the City of Waldron (phosphorus limit 1.0 mg/L) discharge which go to the Poteau River are both already close to, or in attainment, of the 1.5 mg/L phosphorus goal for PS dischargers recommended by the Lake Wister TMDL.

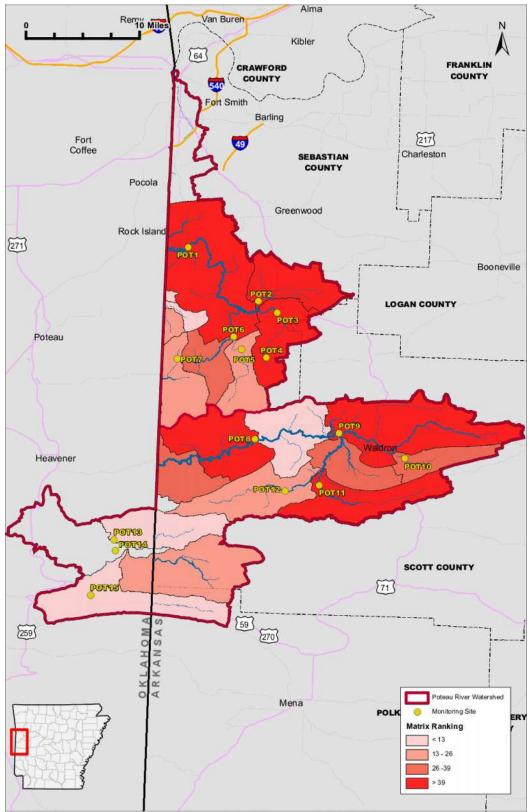
Figure 5.3.2. Matrix rankings of top watershed concerns in the PRW.

According to the matrix ranking, the three key subwatersheds in most need of land use management and source reductions in the James Fork portion of the PRW are Big Branch / Johnson Branch / School House Branch, Cherokee Creek, and Prairie Creek. The three key subwatersheds in most need of land use management and source reductions in the Poteau River portion of the PRW are Bull Creek / Square Rock / East Fork of Poteau River, Ross Creek, and East Shadley Creek. A visualization of the matrix rankings in each of the watersheds is provided below in Figure 5.3.1.

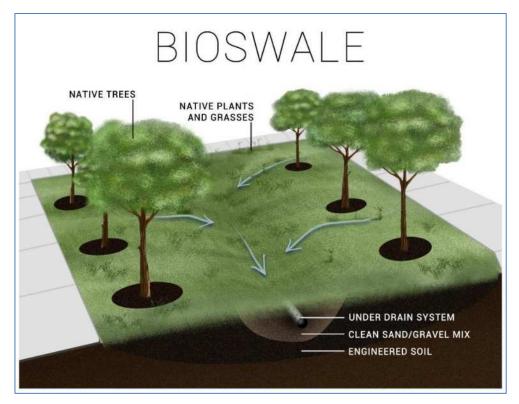
Figure 6.2.1. A bioswale (bioretention) that is effective in reducing pollutant load in stormwater run-off from commercial and institutional areas.

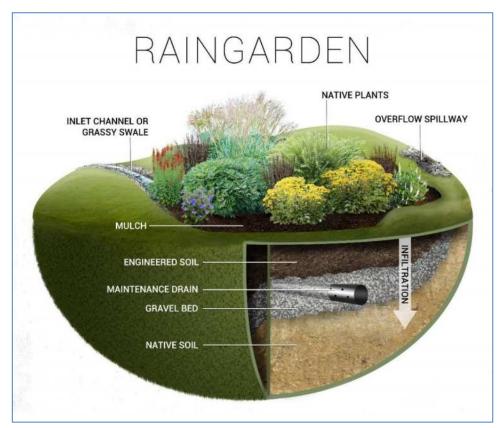
Figure 6.2.2. Example of a raingarden that can be easily and inexpensively installed in most yards and/or commercial areas to improve stormwater quality.

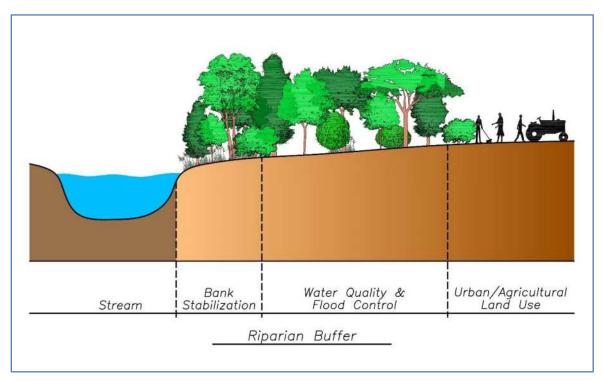
Figure 6.3.1. Generic Representation of the ideal Riparian Buffer Zone.

Buffer widths should be planted as wide as possible on each side of the stream. A width of at least 25 ft on each side of the stream should be targeted. When riparian buffers are considered, more is always better. Buffers should be composed of native vegetation including trees, shrubs, herbaceous plants, and grasses. Figure 6.3.1 presents a representation of how buffers are designed.

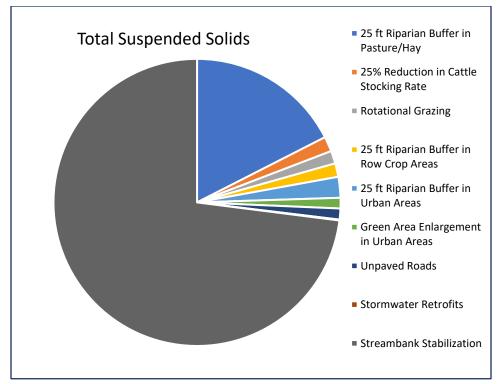
Figure 6.4.1. Source and scale of Total Suspended Solids (TSS) load reductions.

Based on the load reductions projected in Section 6.2 for various BMPs, the most effective for sediment appear to be streambank stabilization and vegetated filter Strips/riparian buffers (Figure 6.4.1). The most effective for N and P removal appear to be streambank stabilization, lowered cattle stocking rate, and 25 feet riparian buffers (Figures 6.4.2 and 6.4.3).

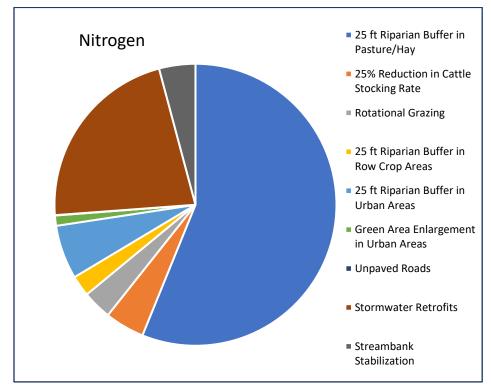
Figure 6.4.2. Source and scale of Nitrogen (N) load reductions.

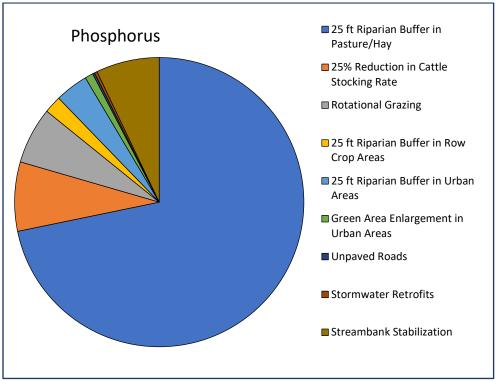
Figure 6.4.3. Source and scale of Phosphorus (P) load reductions.
